Loss of Stability

A ship capsizes while loading cargo.

by CAPTAIN BRENDAN SABURN
U.S. Coast Guard Office of Investigations and Analysis

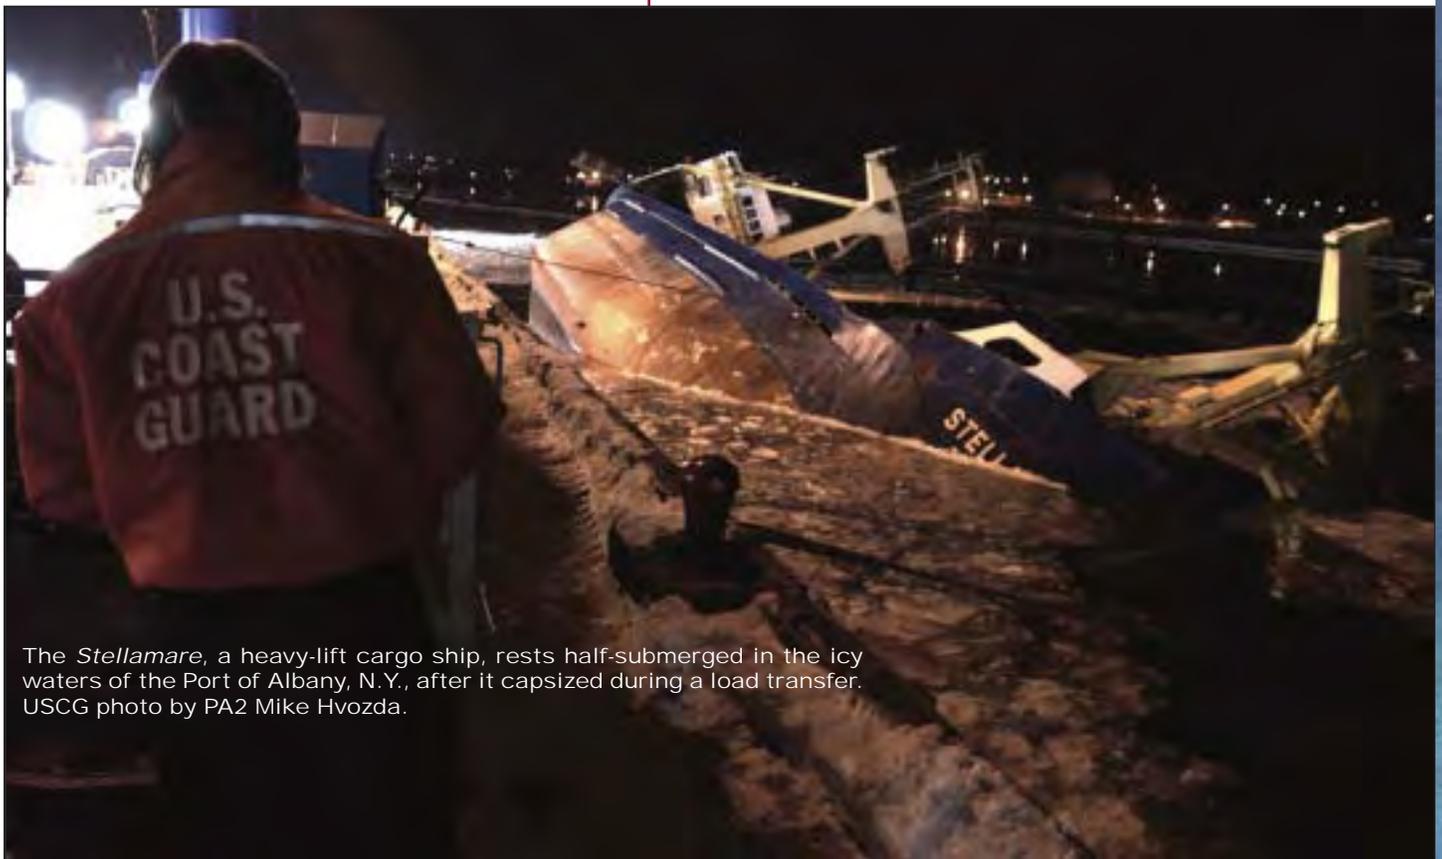
The *Stellamare*, a heavy-lift cargo ship, rests half-submerged in the icy waters of the Port of Albany, N.Y., after it capsized during a load transfer. USCG photo by PA2 Mike Hvozda.

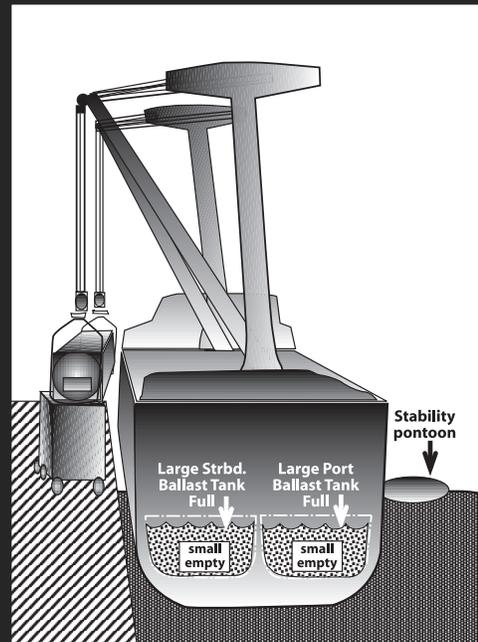
Booms are positioned over the wharf to begin lifting the second generator. At this point, large port and starboard ballast tanks are full. As strain is taken, the stability pontoon becomes misaligned.

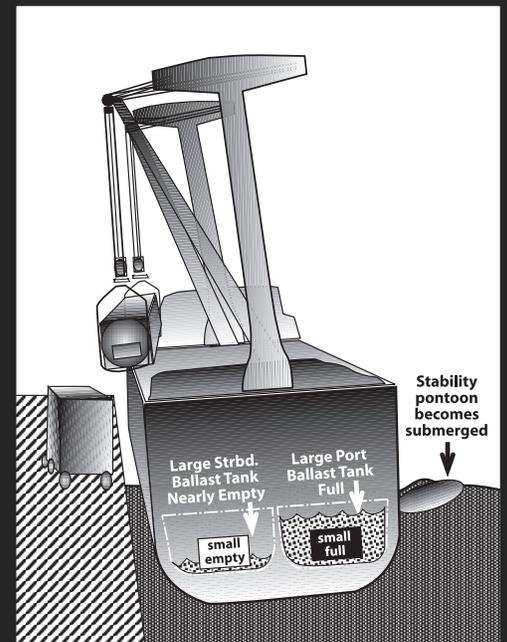
As the generator is lifted, ballast is discharged from the large starboard tanks. Smaller port-side ballast tanks are filling. Pontoon begins to become submerged.

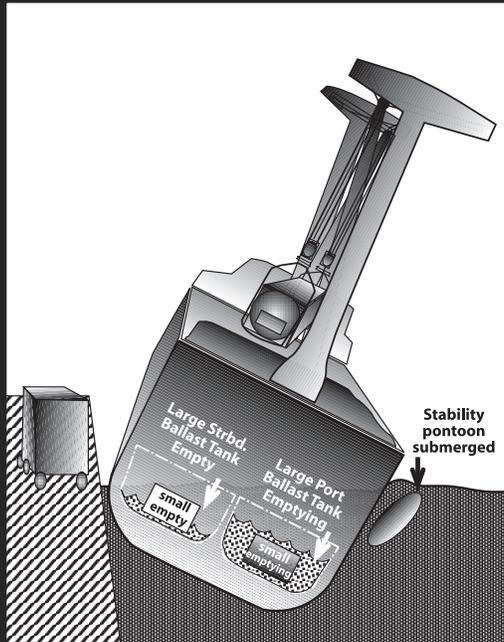
Ship lists to port and discharge of port-side ballast begins. Ship remains listing to port as discharge of port-side ballast begins. The stability pontoon no longer provides additional waterplane area. Additionally, with so much weight (300 tons) suspended from above, and not enough weight (ballast) below, ship is dangerously unstable and capsizes to port.

At some point before the port-side ballast discharge began, the pontoon became submerged and lost its effectiveness. This loss of effective waterplane area meant that the ship, with its suspended load, was unstable, but the captain didn't realize it. The heavy load was suspended on the starboard side—almost in position over the hatch—but the ship was unstable because the pontoon was submerged.

The captain should have given the orders to fill the starboard ballast tanks and top off the port tanks that he had started emptying. Unfortunately, instead, he didn't realize the condition of instability caused by the submerged pontoon and continued discharging port-side ballast in hope of alleviating the port list. At this point, the captain asked the chief engineer if ballast could be discharged any faster. The center of gravity got higher with every ton of ballast discharged, and the situation became more dangerous.
