Loss of Stability

A ship capsizes while loading cargo.

by CAPTAIN BRENDAN SABURN
U.S. Coast Guard Office of Investigations and Analysis

Lessons Learned

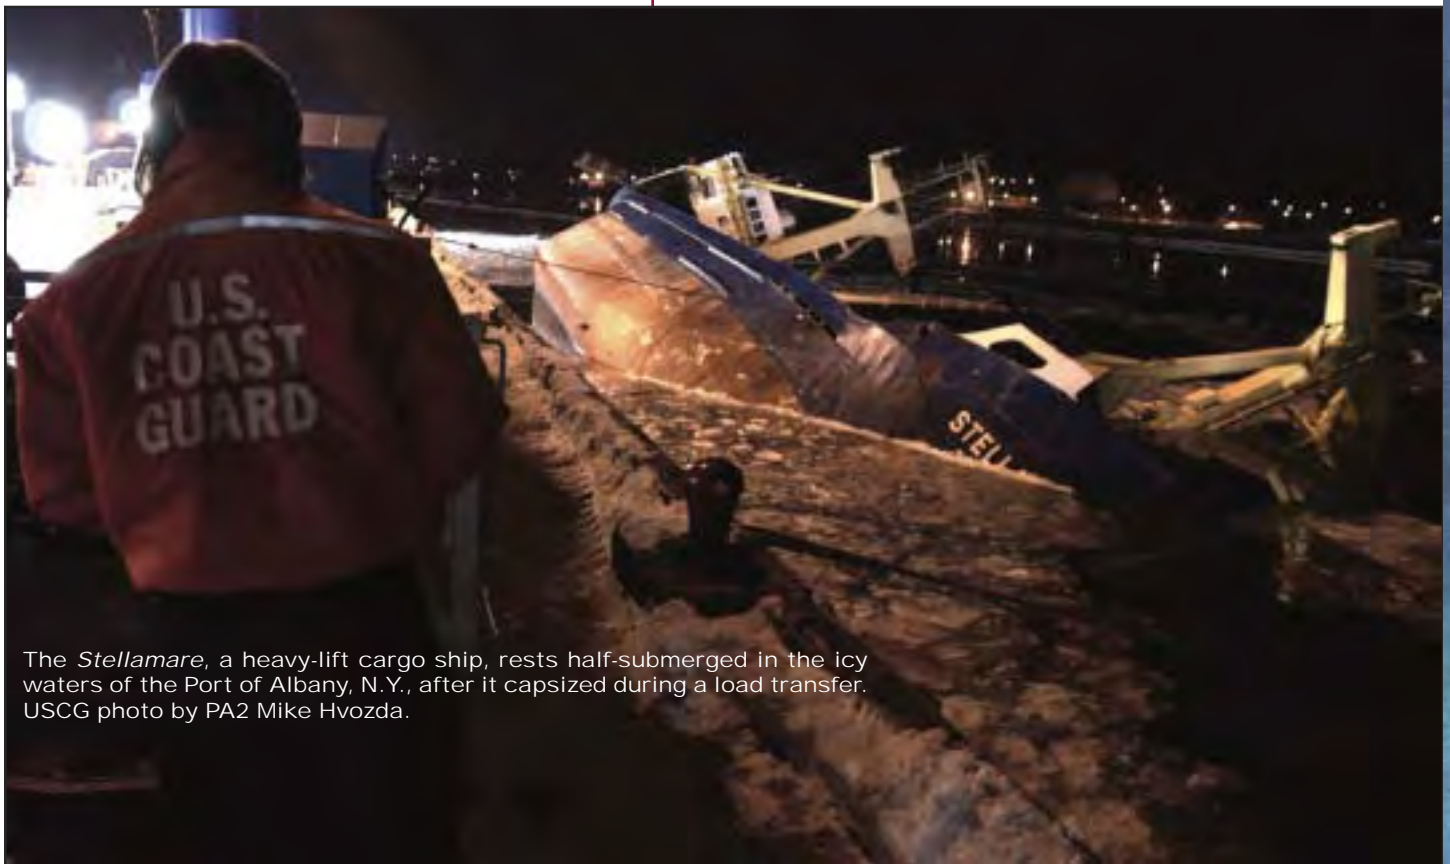
The *Stellamare*, a heavy-lift cargo ship, rests half-submerged in the icy waters of the Port of Albany, N.Y., after it capsized during a load transfer. USCG photo by PA2 Mike Hvozda.

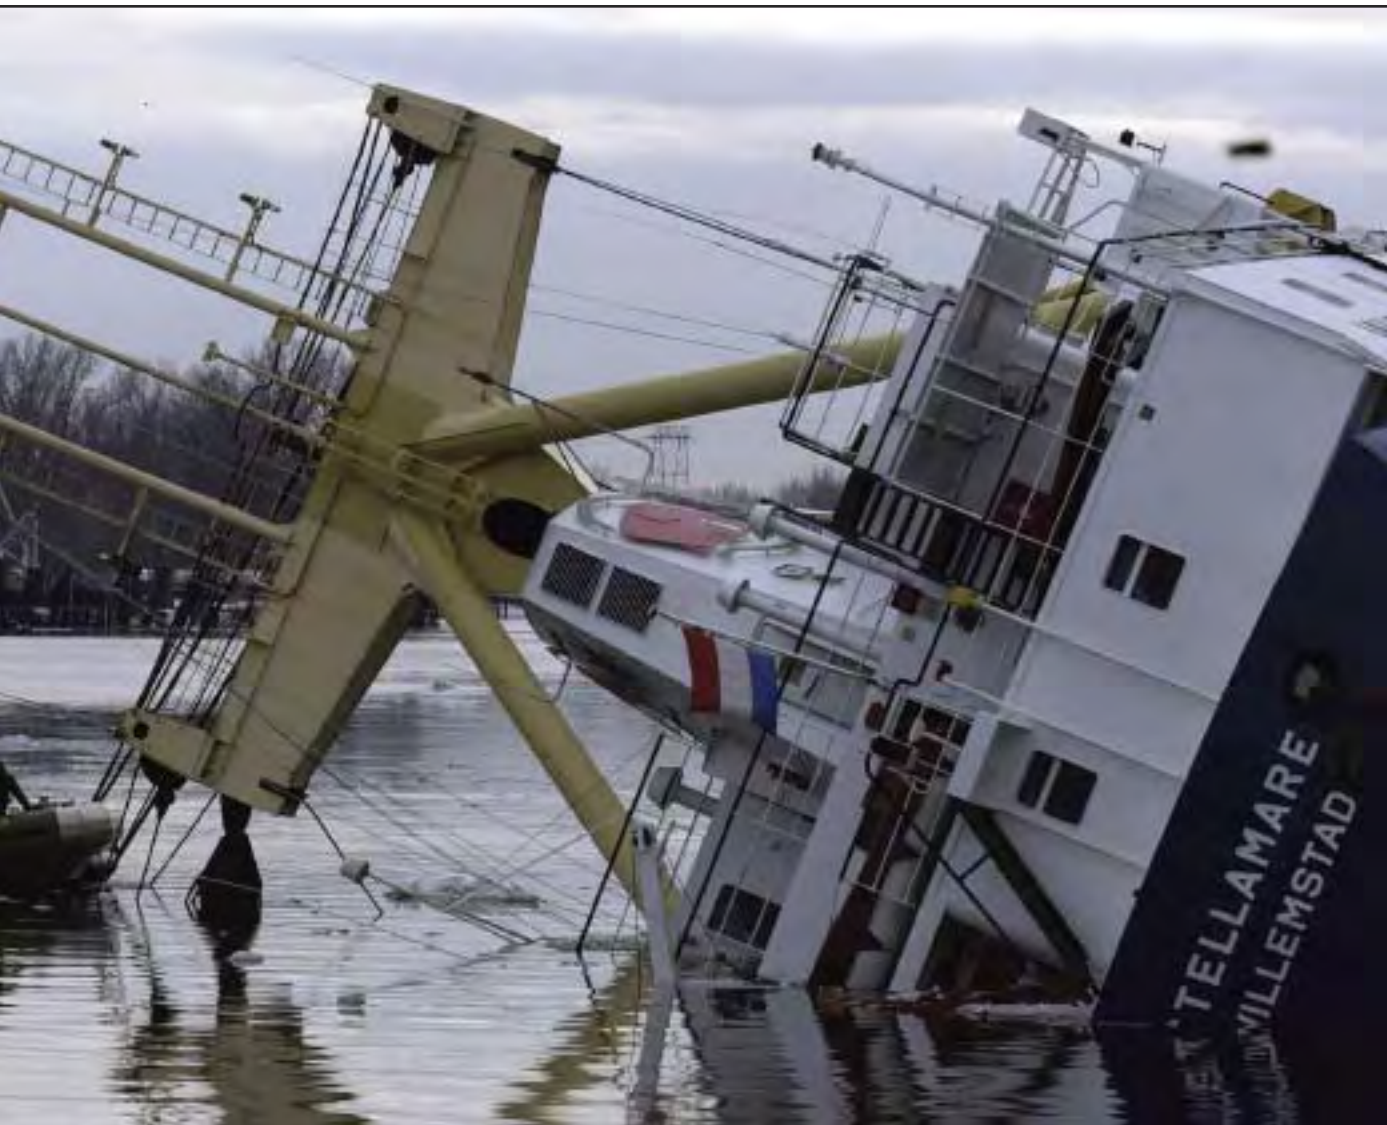
Divers approach the ship to search for missing crewmen. USCG photo by PA2 Mike Hvozda.

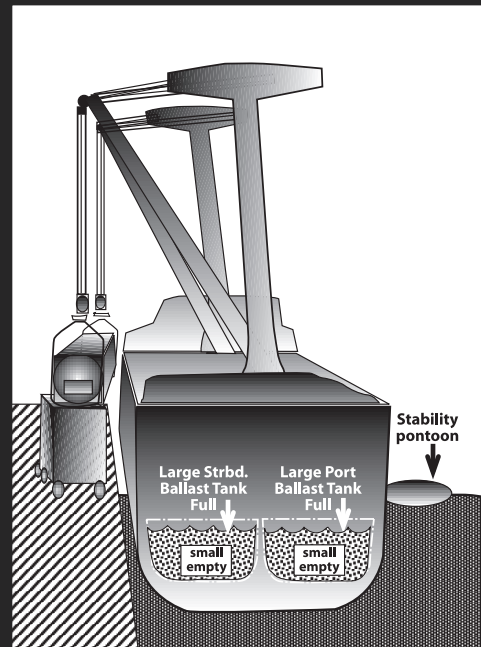
Booms are positioned over the wharf to begin lifting the second generator. At this point, large port and starboard ballast tanks are full. As strain is taken, the stability pontoon becomes misaligned.

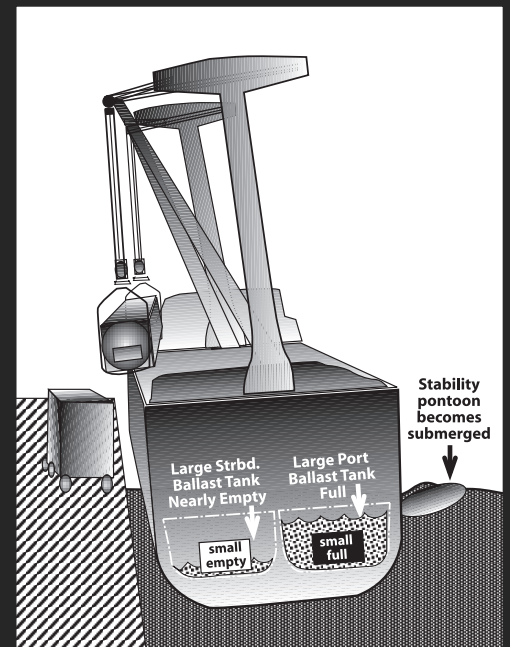
As the generator is lifted, ballast is discharged from the large starboard tanks. Smaller port-side ballast tanks are filling. Pontoon begins to become submerged.

At some point before the port-side ballast discharge began, the pontoon became submerged and lost its effectiveness. This loss of effective waterplane area meant that the ship, with its suspended load, was unstable, but the captain didn't realize it. The heavy load was suspended on the starboard side—almost in position over the hatch—but the ship was unstable because the pontoon was submerged.

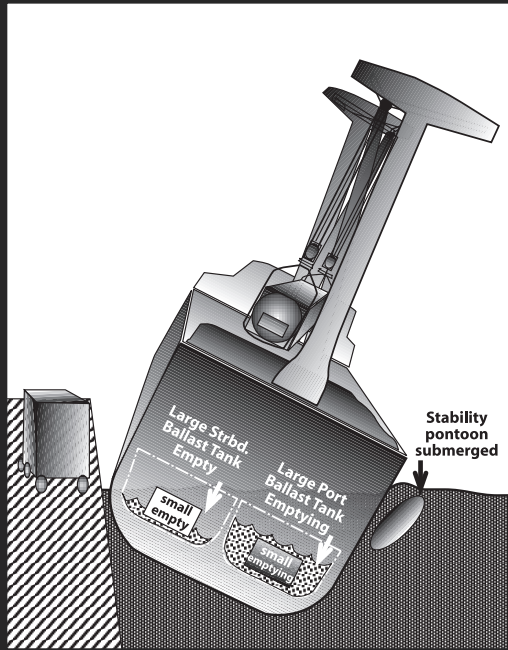
Ship lists to port and discharge of port-side ballast begins. Ship remains listing to port as discharge of port-side ballast begins. The stability pontoon no longer provides additional waterplane area. Additionally, with so much weight (300 tons) suspended from above, and not enough weight (ballast) below, ship is dangerously unstable and capsizes to port.

The suspended weight was hanging slightly to starboard and all the port-side ballast tanks were full. At that point, the captain realized the ship was listing to port.⁶ The best course of corrective action would have been to ballast. Usually, stability teachings dictate ballasting an unstable ship first on the low side, so the ship can't flop from a port list to a starboard list and capsize (toward the wharf in this case). However, since all the port-side ballast tanks were still nearly full, the alternative should have been to ballast on the starboard side; that is, ballast anywhere possible to make the ship less unstable. When in dire straits, this could even include filling tanks that are normally used as fuel tanks.

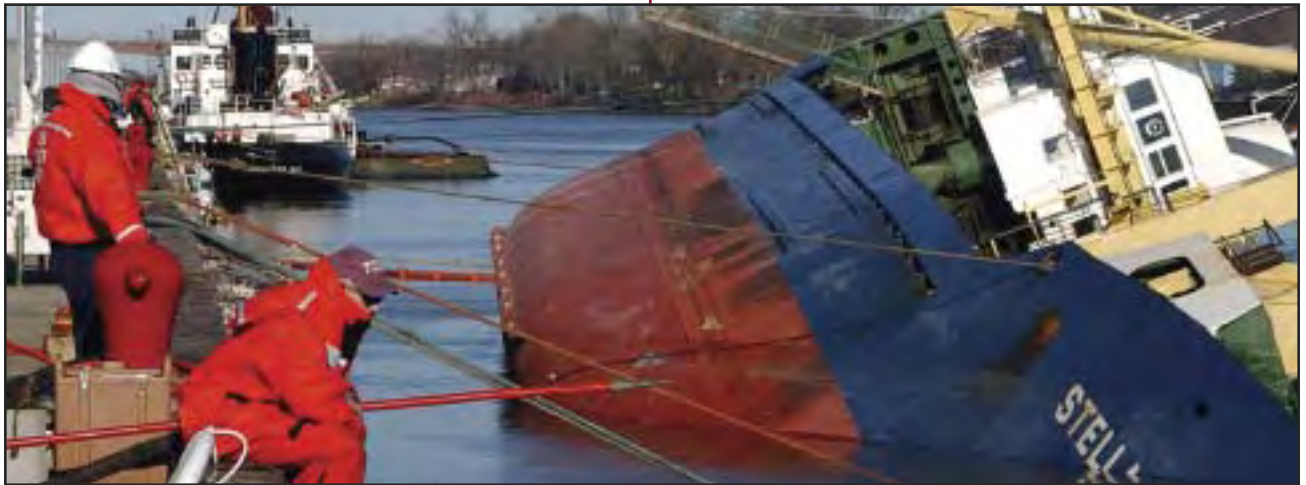
Salvage work continues. USCG photo by PA2 Mike Hvozda.
