Loss of Stability

A ship capsizes while loading cargo.

by CAPTAIN BRENDAN SABURN
U.S. Coast Guard Office of Investigations and Analysis

Lessons Learned

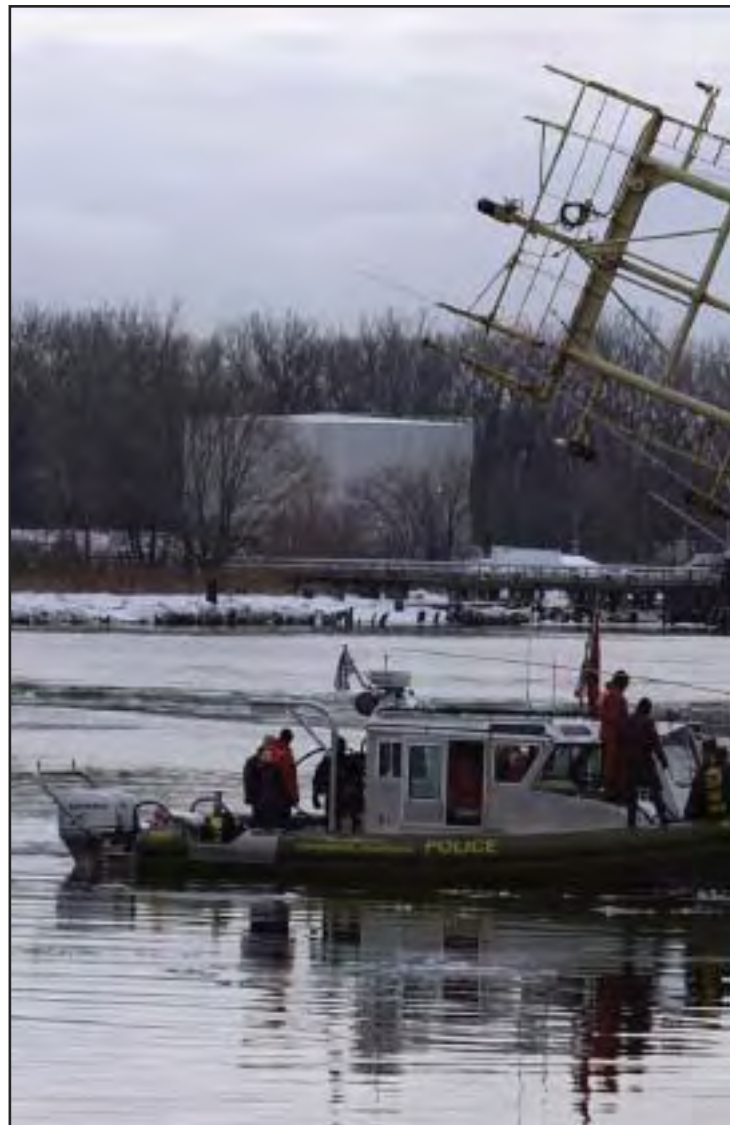
A stability pontoon is a floating vessel that makes a 300-ton lift and load possible. For a ship this size, the pontoon is approximately 50 meters in length and floats alongside the outboard side of the ship. From its stowed position on deck, it’s picked up by one of the booms and carefully lowered down over the side through a track that serves as the attachment bracket. The pontoon increases the ship’s “effective breadth;” the wider a vessel, the more stable it is. The two-di-

mensional area of the ship's waterplane⁴ has been increased in the width dimension, making the ship a lot more stable. This ship used a stability pontoon on the outboard side that day.

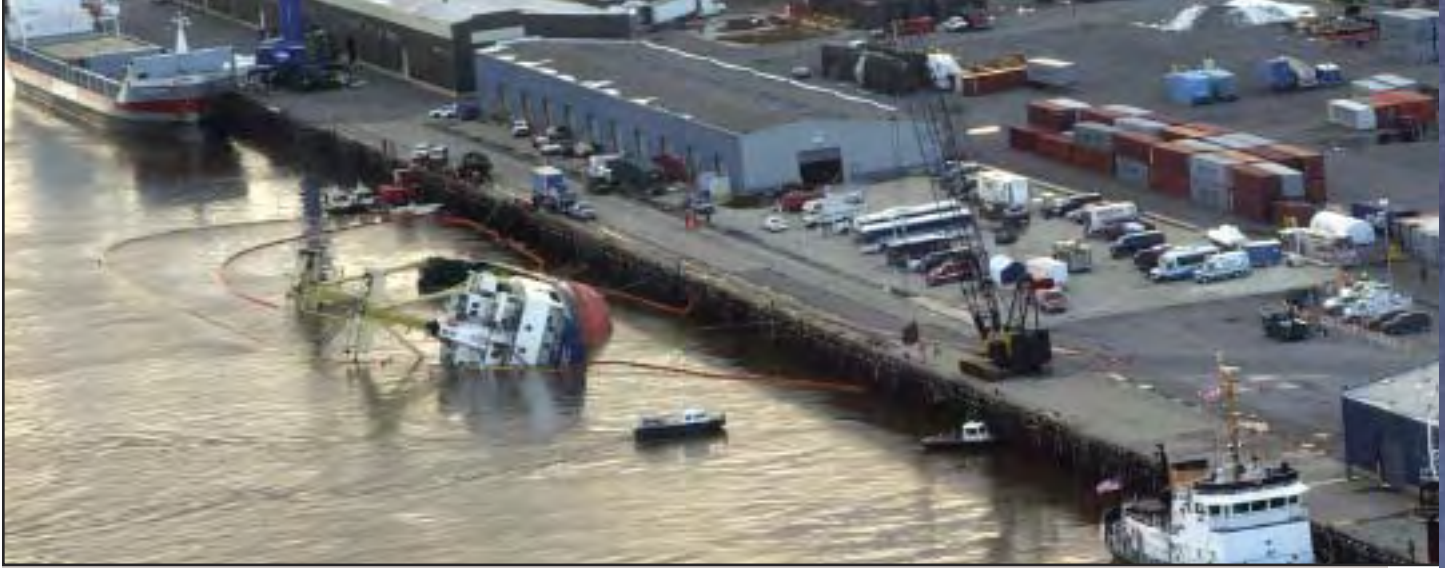
Nine thousand gallons (1,200 cubic feet¹) of the ship's fuel oil discharged out through the tank vents before the ship could be refloated. Fuel seeped through the port-side tank vents because the ship was submerged on its port side (on the bottom) after capsizing. The simple float balls that act as check valves² in the goose-neck tank vents can't function effectively unless the sunken ship is upright. Immediately after capsizing, river water entered the fuel tanks and fuel oil exited through the port-side goose-necks as the vents were submerged to the bottom of the river.
